# AIGI Environmental Incorporated Inspection Lab

## Inspection Report

No: JC202211010

| Product | Mechanical Seal | Model | 318CYC Φ80mm |

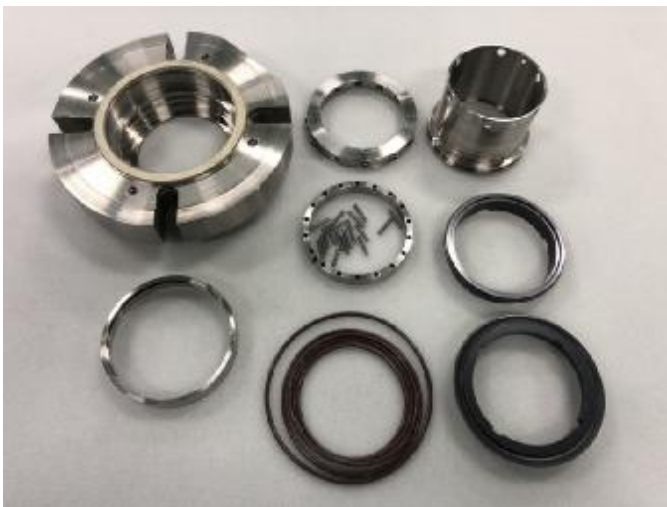
Before the test

Mechanical seal parts disassembled photos, before and after the test:

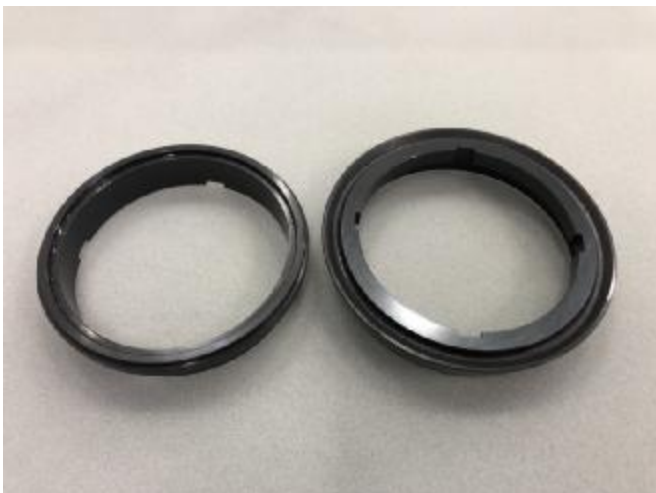
Before the test

Mechanical seal sealing surface, before and after the test:

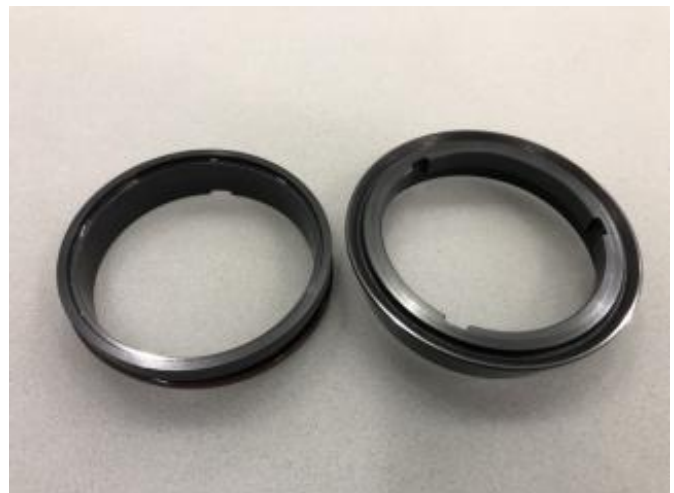
After the test

| Inspection item | | Unit | Nameplate parameter | Technical requirements | Inspected data | | | | Result |
|---|---|---|---|---|---|---|---|---|---|
| Wear Loss | | mm | — | ≤0.02 | Cyclone SIC Rotary Face Thickness | Before | After | Loss | Pass |
| | | | | | | 18.605 | 18.605 | 0 | |
| | | | | | SIC Stationary Thickness | Before | After | Loss | Pass |
| | | | | | | 20.070 | 20.070 | 0 | |
