# AIGI Environmental Incorporated Inspection Lab

## Inspection Report

No: JC202211009

| Product | Mechanical Seal | Model | 318CYC Φ60mm |

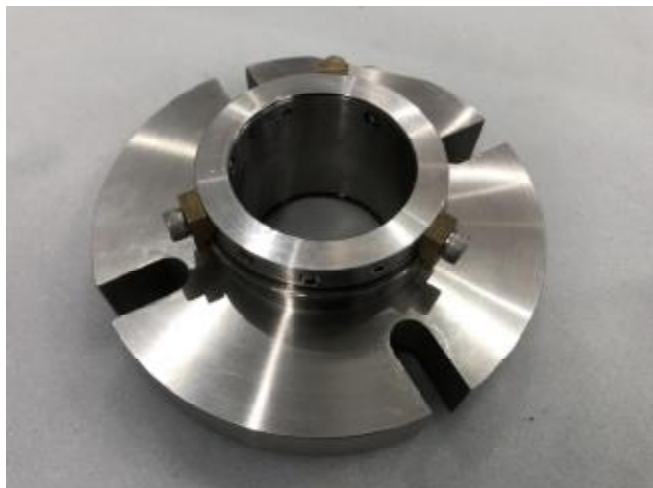
Before the test

Mechanical seal photos, before and after the test:

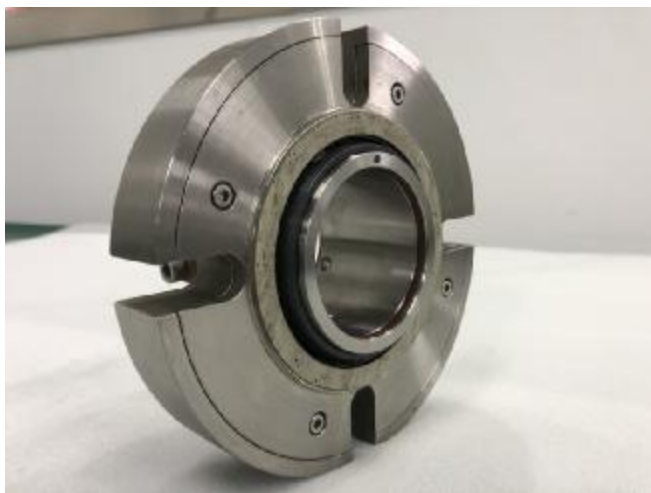
Before the test

Mechanical seal entering the chamber photos, before and after the test

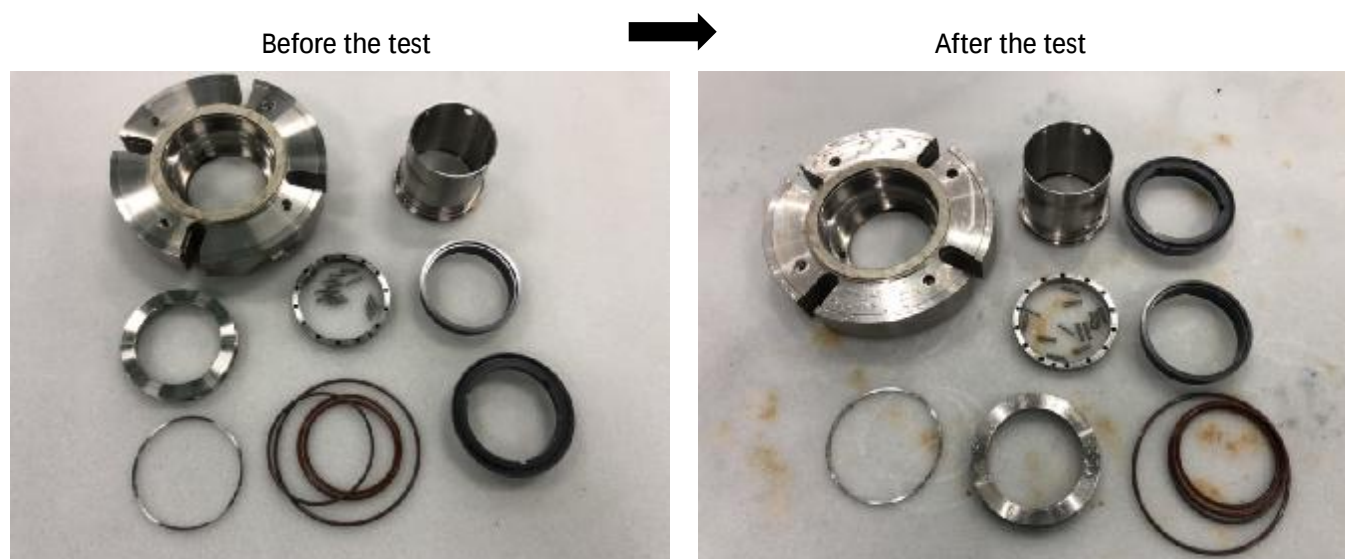
Mechanical seal parts disassembled photos, before and after the test:

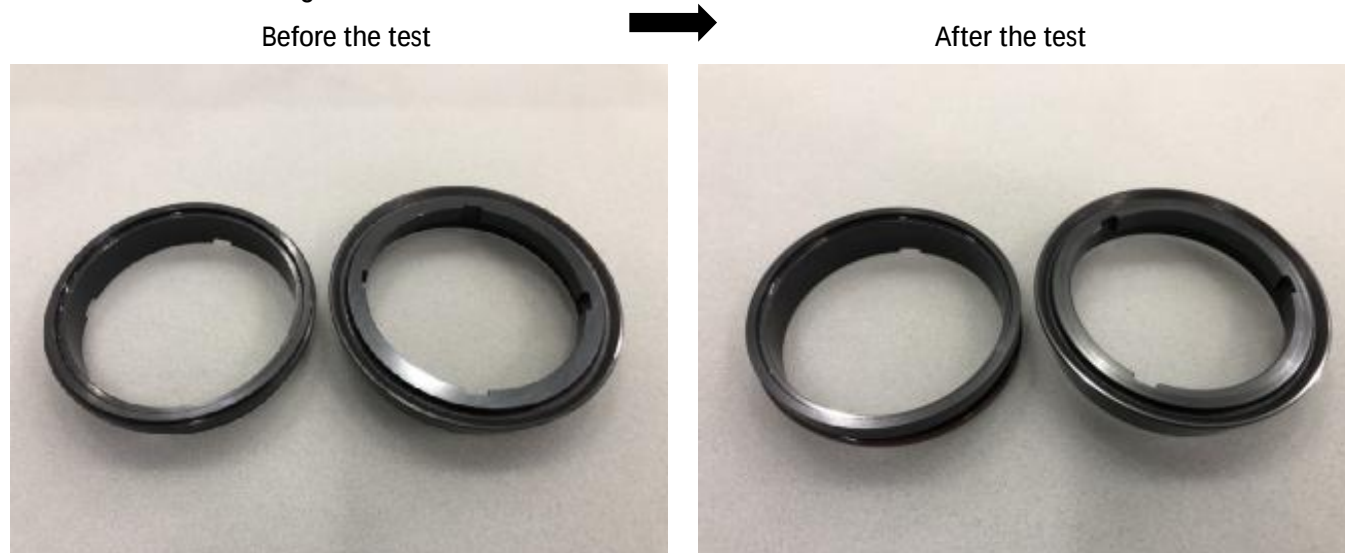
Mechanical seal sealing surface, before and after the test:
