# AIGI Environmental Incorporated Inspection Lab

## Inspection Report

No: JC202211006

| Product | Mechanical Seal | Model | 318CYC Φ60mm |

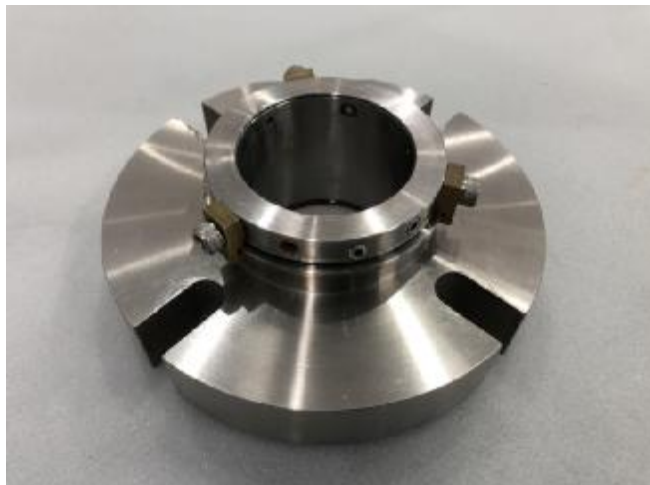
Before the test

Mechanical seal photos, before and after the test:

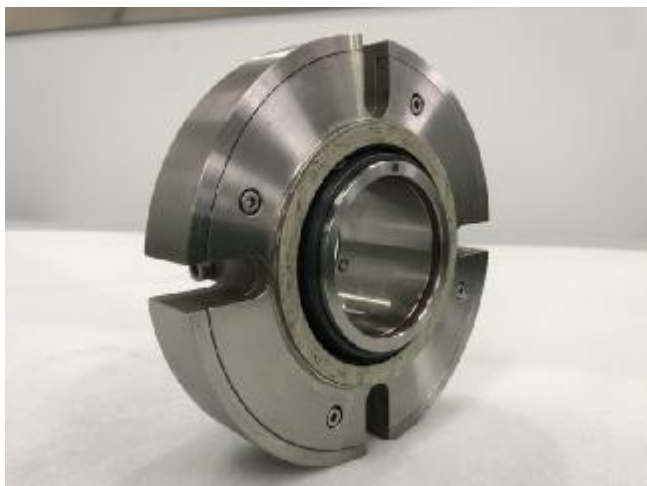
Before the test

Mechanical seal entering the chamber photos, before and after the test

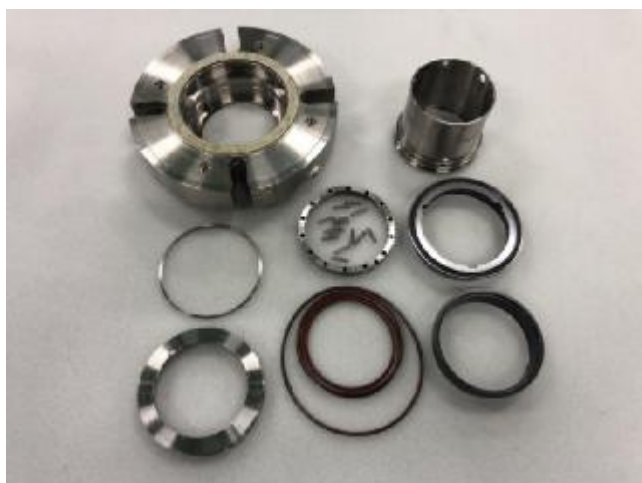
Before the test

Mechanical seal parts disassembled photos, before and after the test:

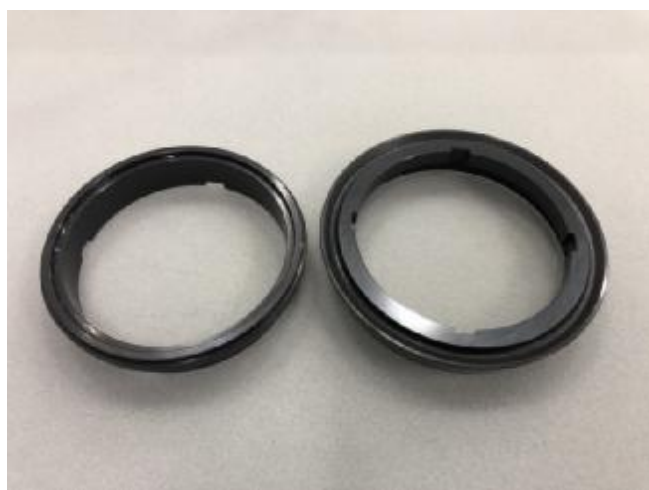
Before the test

| Inspection item | | Unit | Nameplate parameter | Technical requirements | Inspected data | | | | Result |
|---|---|---|---|---|---|---|---|---|---|
| Wear Loss | | mm | — | ≤0.02 | Cyclone SIC Rotary Face Thickness | Before | After | Loss | Pass |
| | | | | | | 15.600 | 15.600 | 0 | |
| | | | | | SIC Stationary Thickness | Before | After | Loss | Pass |
| | | | | | | 16.250 | 16.250 | 0 | |

Mechanical seal sealing surface, before and after the test:
