# AIGI Environmental Incorporated Inspection Lab

## Inspection Report

No: JC202211005

| Product | Mechanical Seal | Model | 318CYC Φ60mm |

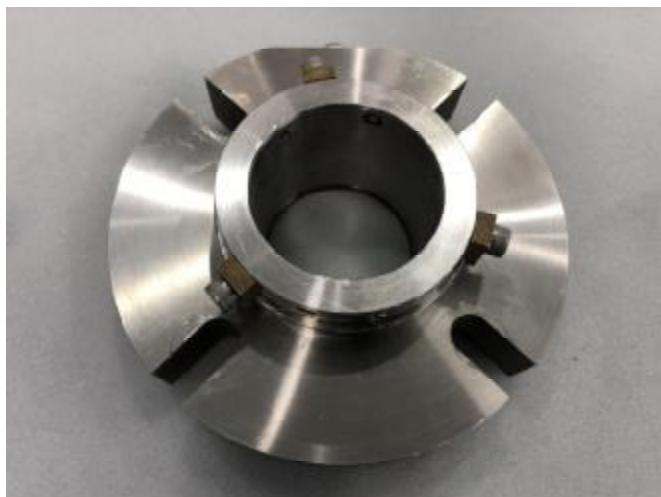
Before the test

Mechanical seal photos, before and after the test:

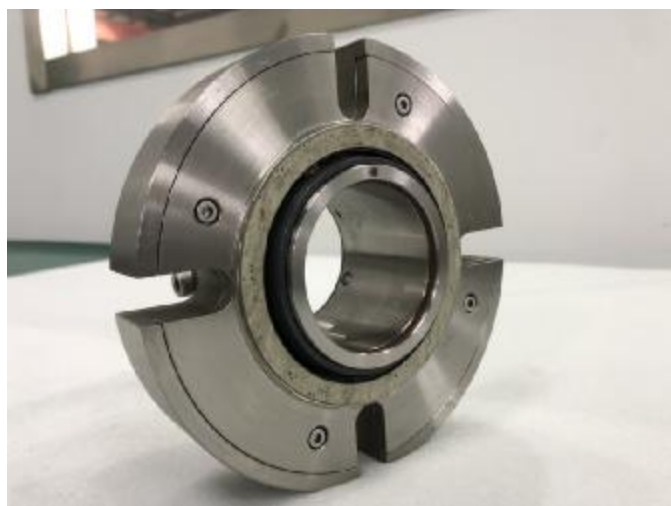
Before the test

Mechanical seal entering the chamber photos, before and after the test

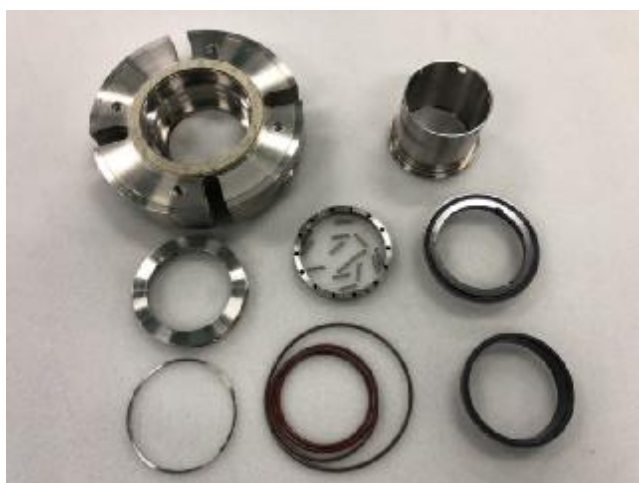
Before the test

Mechanical seal parts disassembled photos, before and after the test:

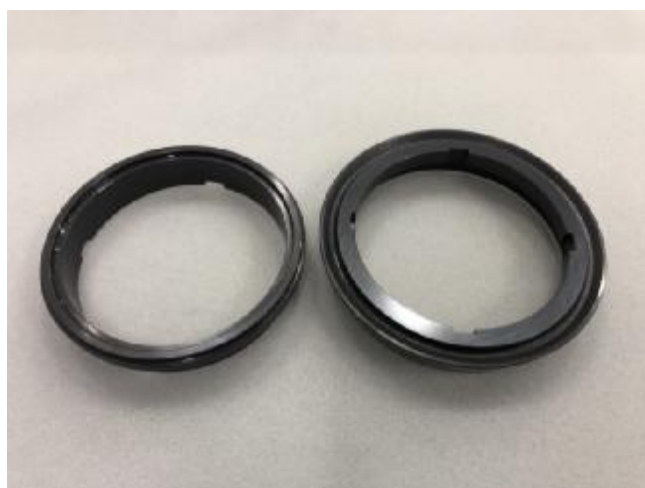
Before the test

| Inspection item | | Unit | Nameplate parameter | Technical requirements | Inspected data | | | | Result |
|---|---|---|---|---|---|---|---|---|---|
| Wear Loss | | mm | — | ≤0.02 | Cyclone SIC | Before | After | Loss | Pass |
| | | | | | Rotary Face Thickness | 15.600 | 15.600 | 0 | |
| | | | | | SIC Stationary | Before | After | Loss | Pass |
| | | | | | Thickness | 16.280 | 16.280 | 0 | |

Mechanical seal sealing surface, before and after the test:
