# AIGI Environmental Incorporated Inspection Lab

## Inspection Report

No: JC202302003

Inspection items: Run-in test of Cyclone seal in sirup

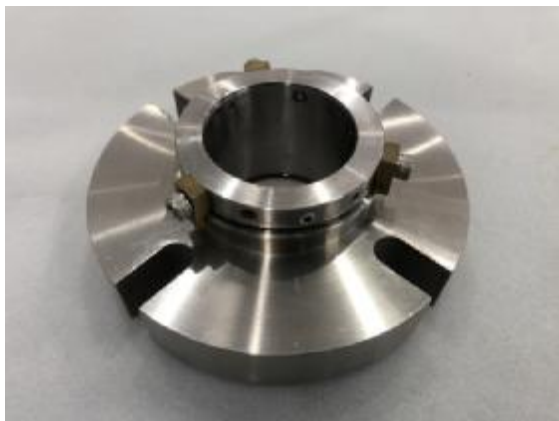
Before the test

Mechanical seal photos, before and after the test:

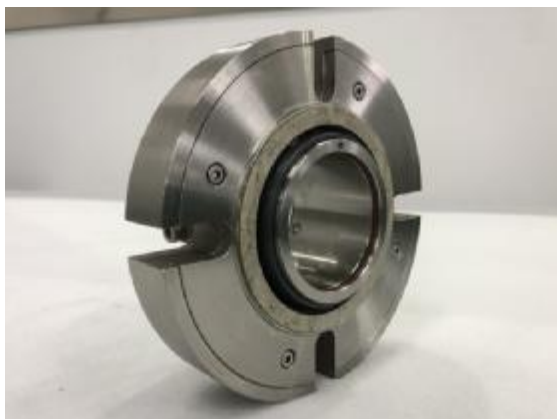
Before the test

Mechanical seal entering the chamber photos, before and after the test

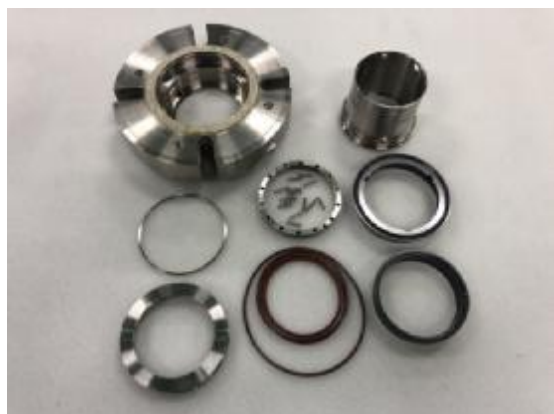
Before the test

Mechanical seal parts disassembled photos, before and after the test:

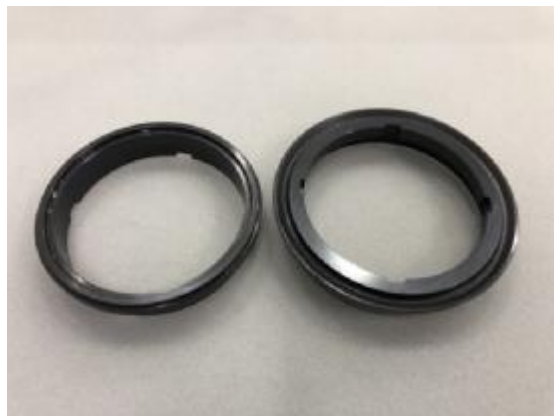
Before the test

Mechanical seal sealing surface, before and after the test:
